Navajo Abandoned Uranium Mine Site Screen Report

Pat AUM Site

Navajo AUM Eastern Region

May 2009

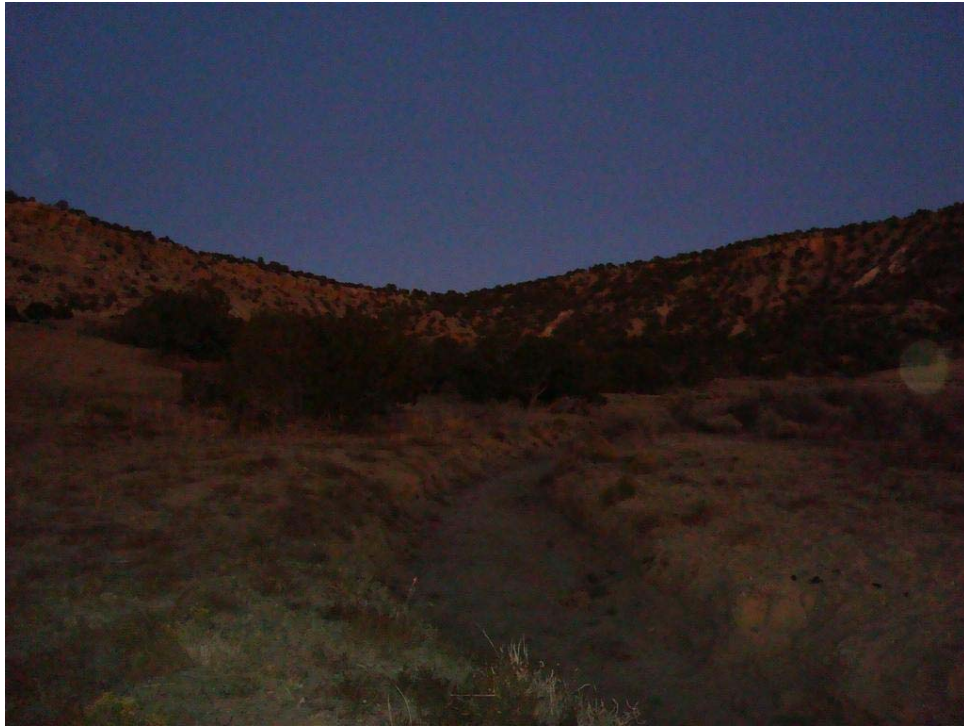
Reclamation status of the mine sites are currently unknown. No visible signs of reclamation were observed. No mining operations were apparent. No waste piles, adits, or other mine features were observed during the site visit.

Photo 1. Pat Mine site, towards the east

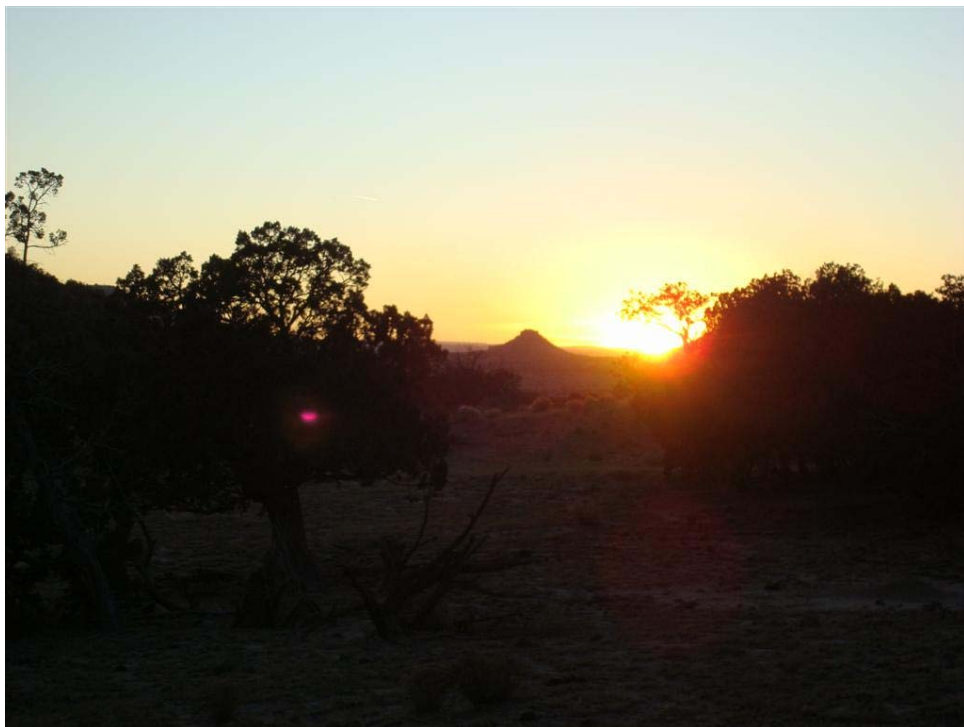
Photo 2. Pat Mine site, towards the west

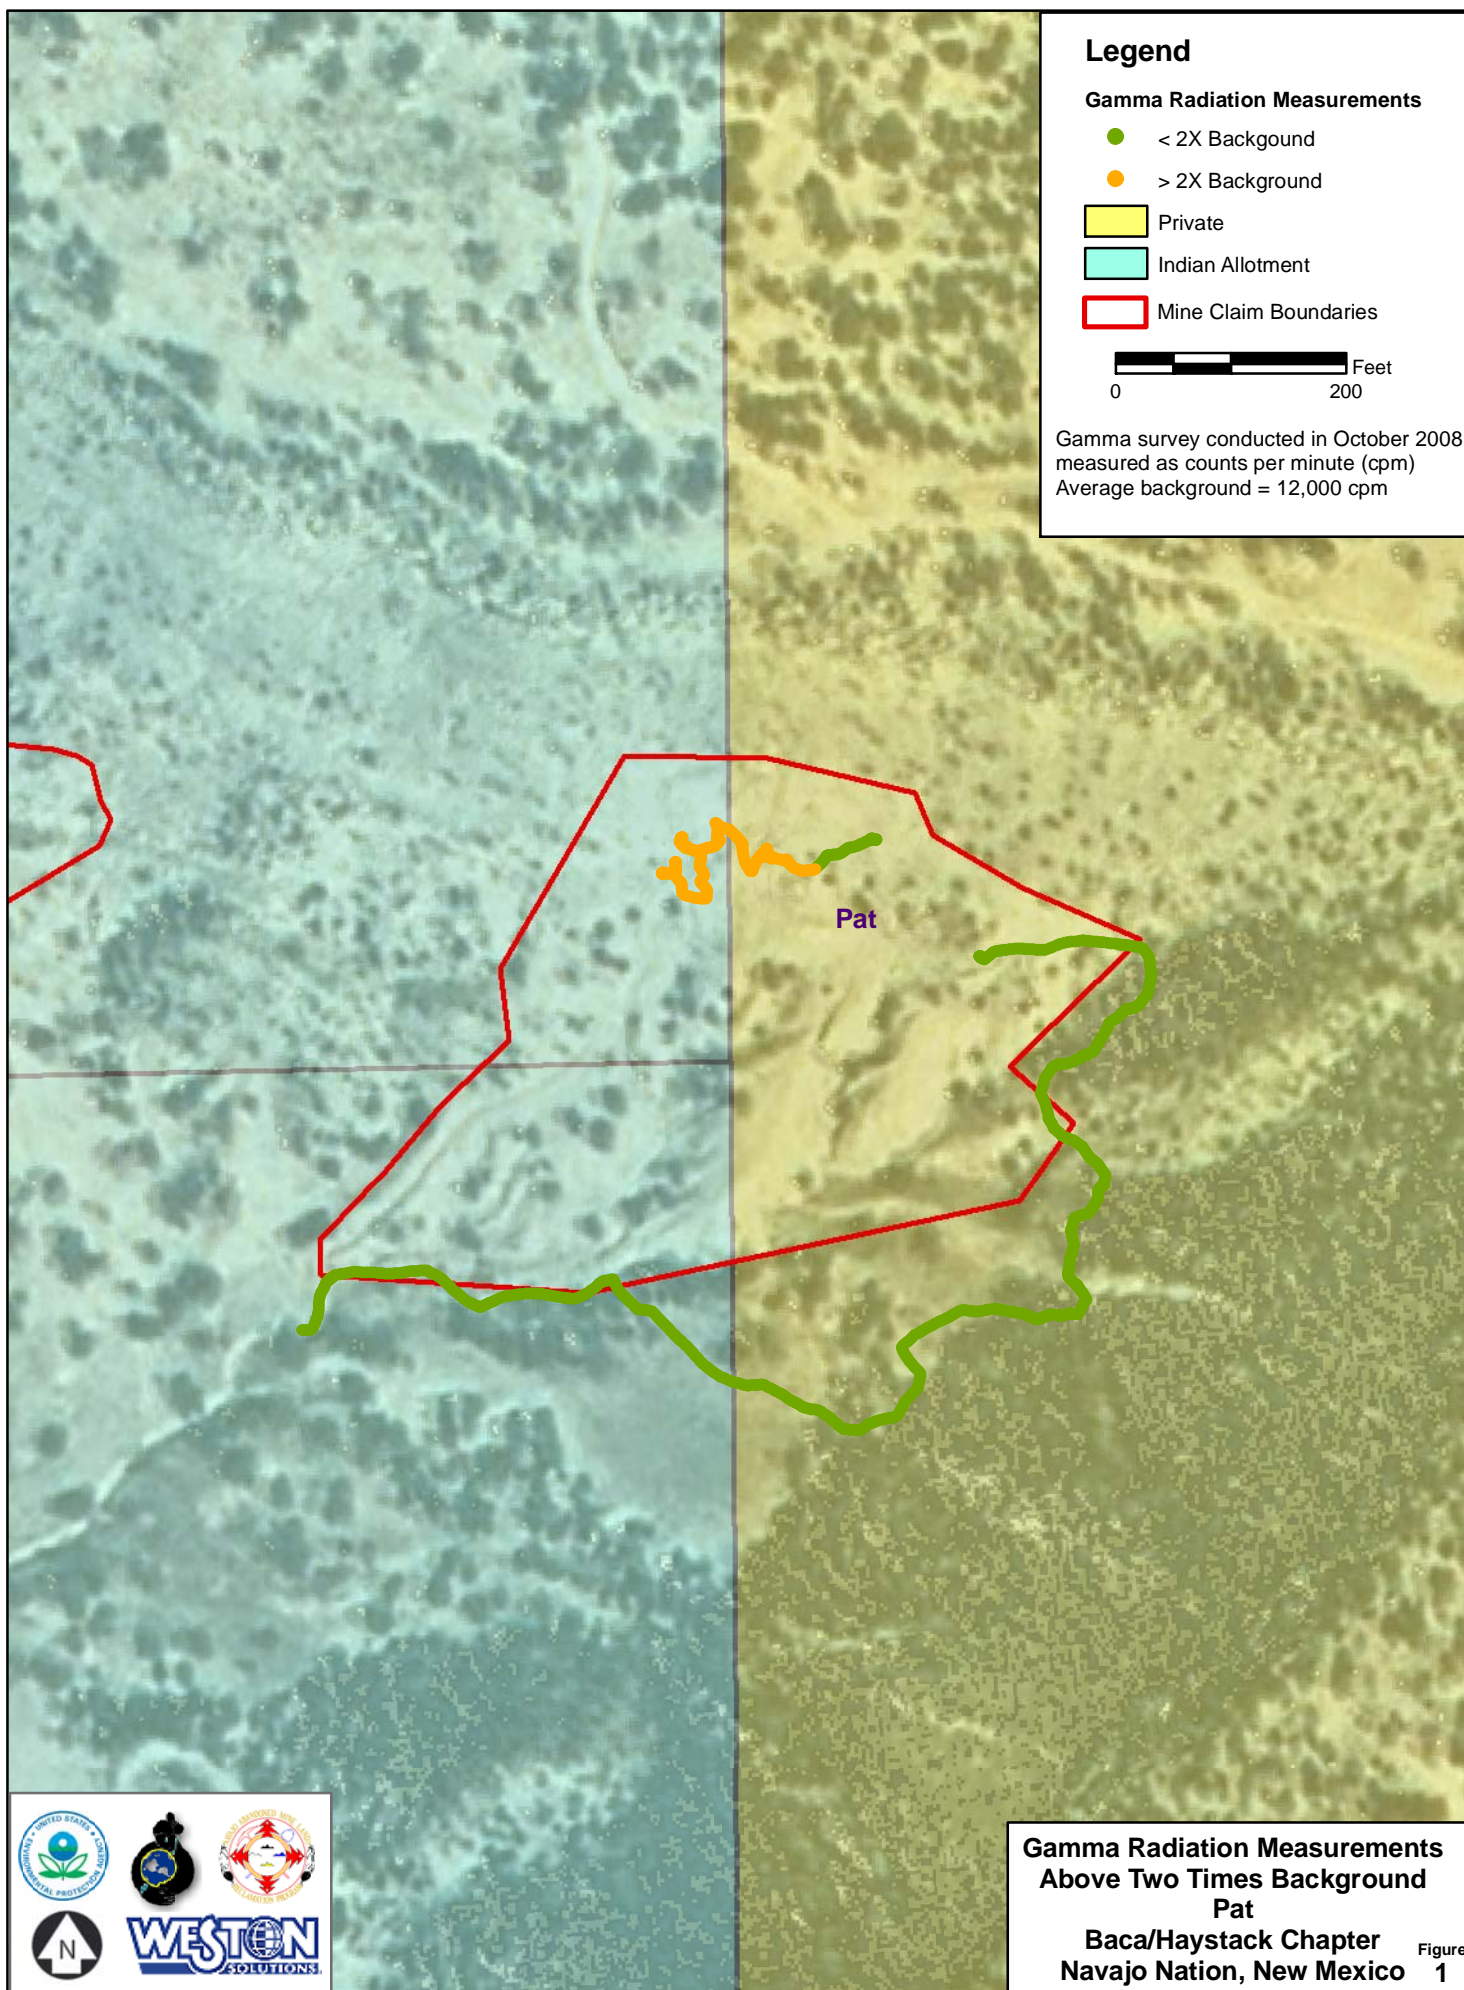
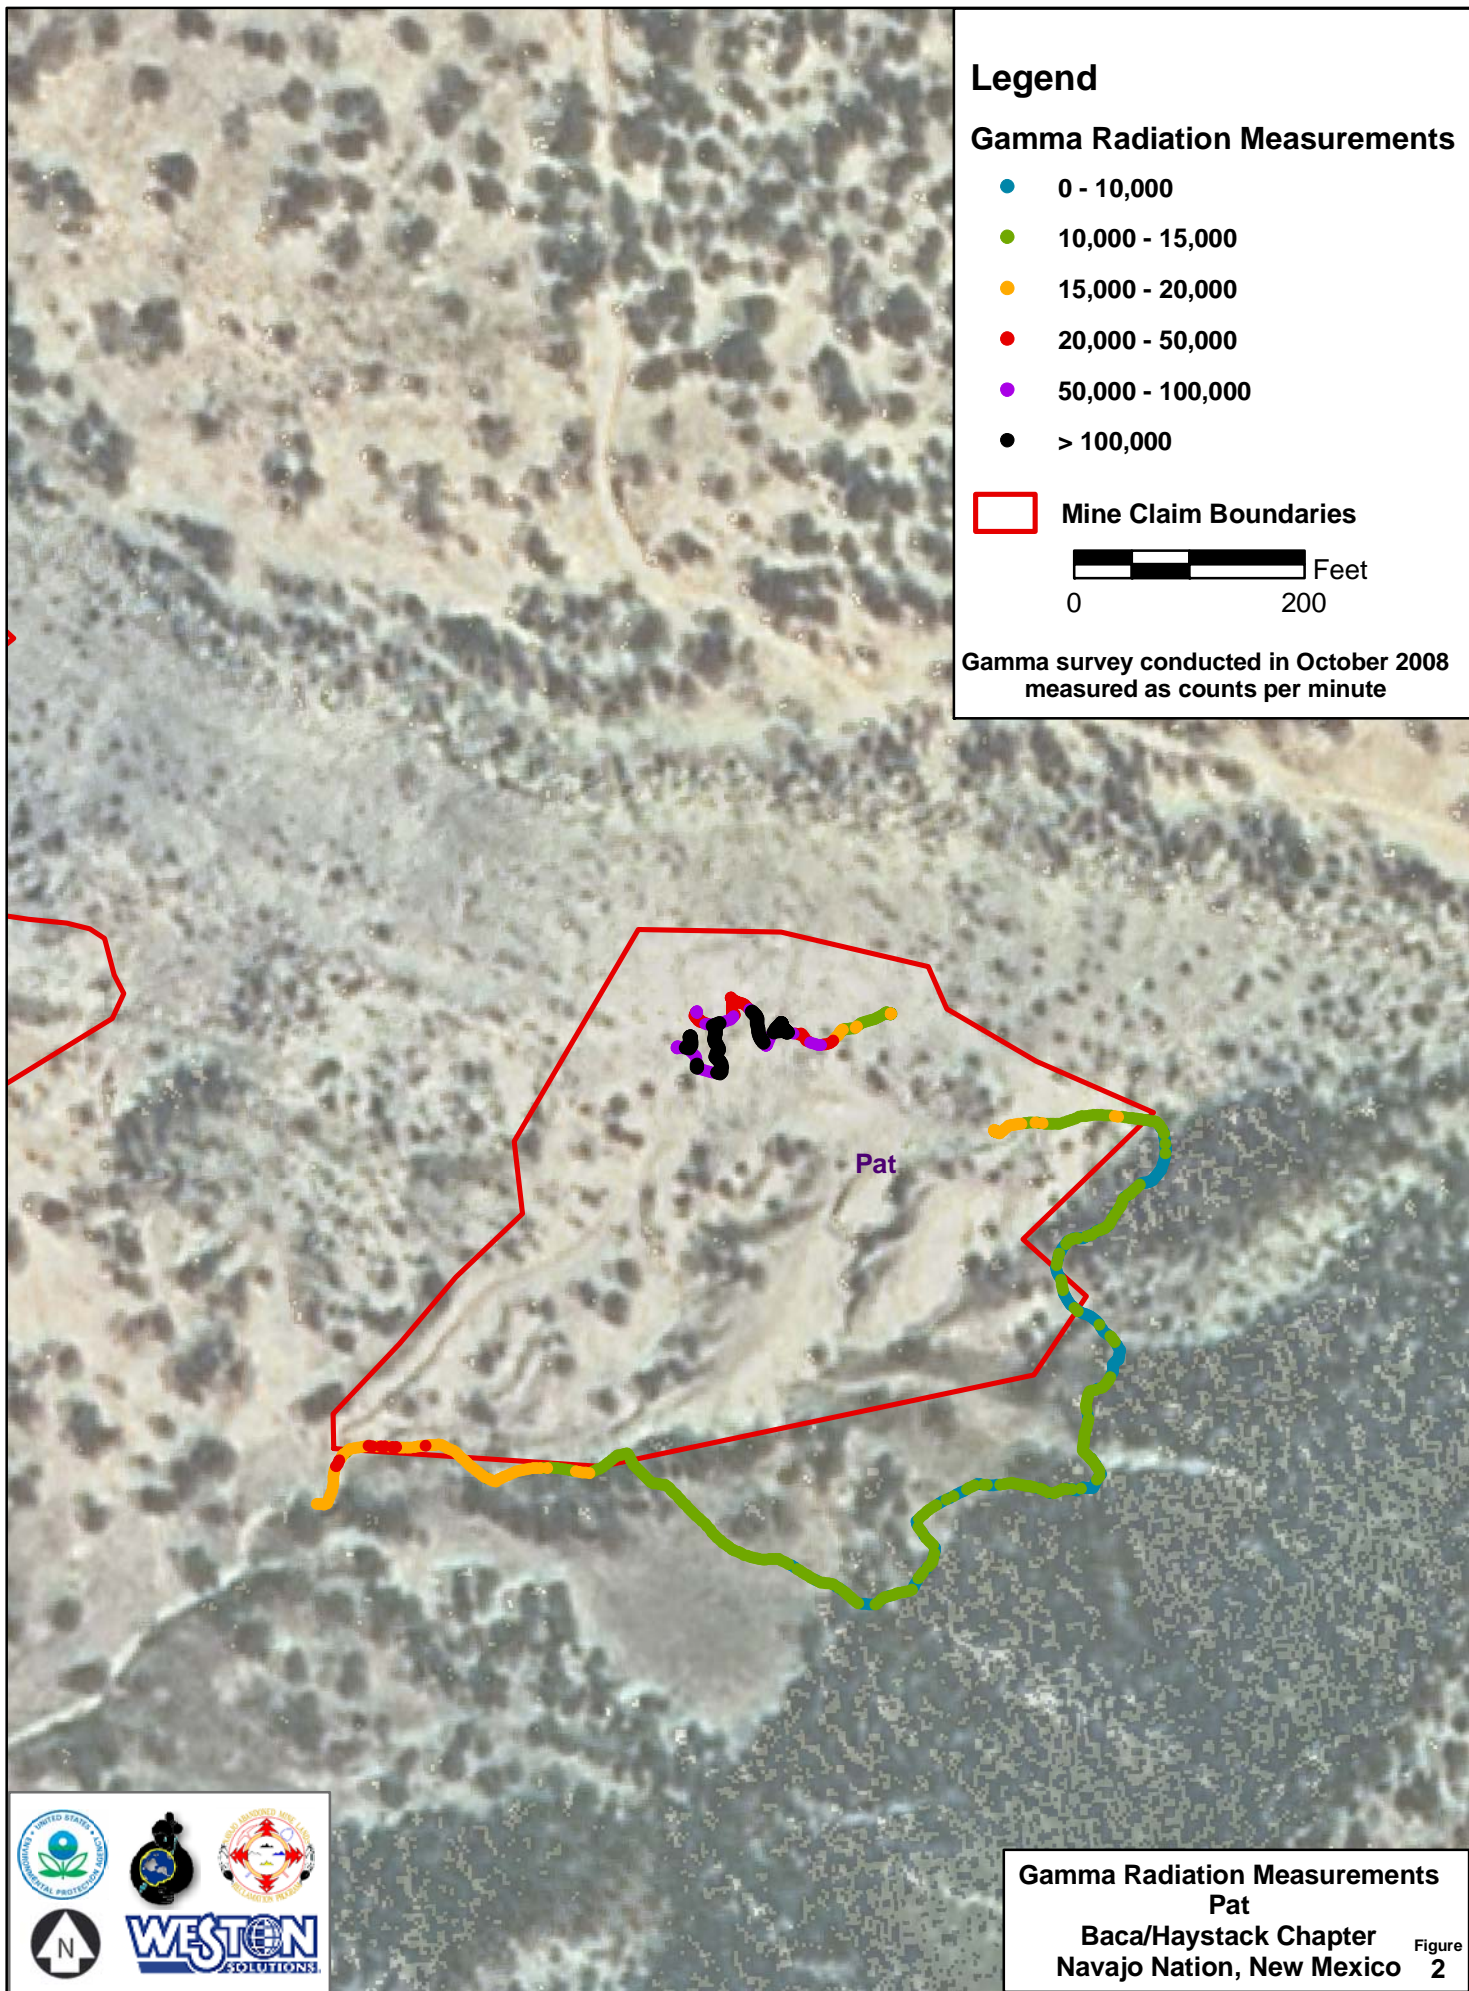
- See Figures 1 and 2

A total of 1,680 gamma radiation measurements were collected from mine sites, ranging from 6,784 cpm to 647,159 cpm. The measurements are represented in Figures 1 and 2. The New Mexico Mining and Minerals Division identified radiological measurements levels at the stockpile as 1000 counts per second (cps); and the stope as 150 cps.

Presented in Figures 1 and 2
